West Lake Landfill Vicinity

**Radiological Survey and Sampling
November 4-6, 2015
Final Report**

Hazardous Waste Program
Federal Facilities Section
March, 2016

MISSOURI
DEPARTMENT OF
NATURAL RESOURCES

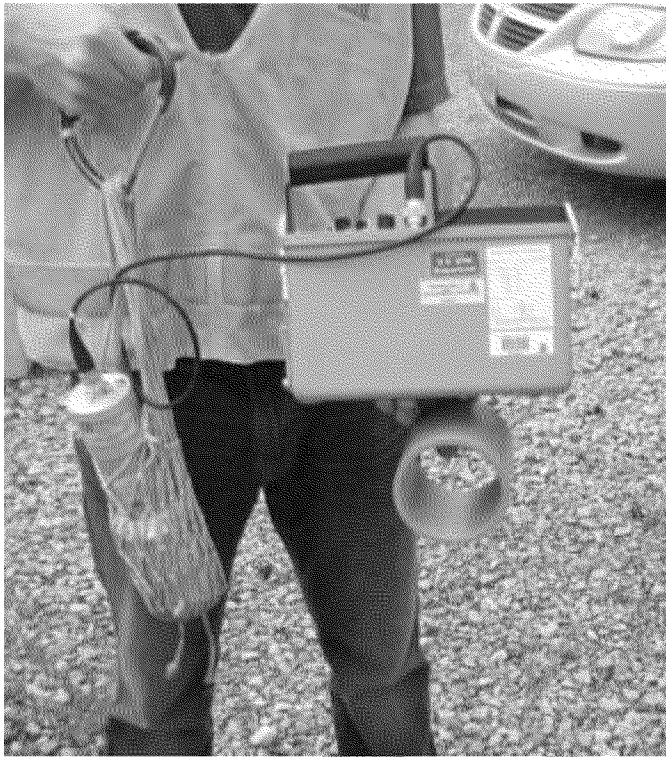
EPA Equipment Y: Ludlum model 2221 with 44-20 NaI Gamma Scintillator detector – This field equipment was brought by and periodically used by EPA personnel at some sampling locations(Photograph 1.)

Photograph 1: EPA Ludlum 2221 with NaI 44-20 detector and directional shield attachment (EPA Equipment Y)
